# Analysis of the Causes and Consequences of Neutron Guide Tube Failures

J. M. Rowe

September 15, 2005

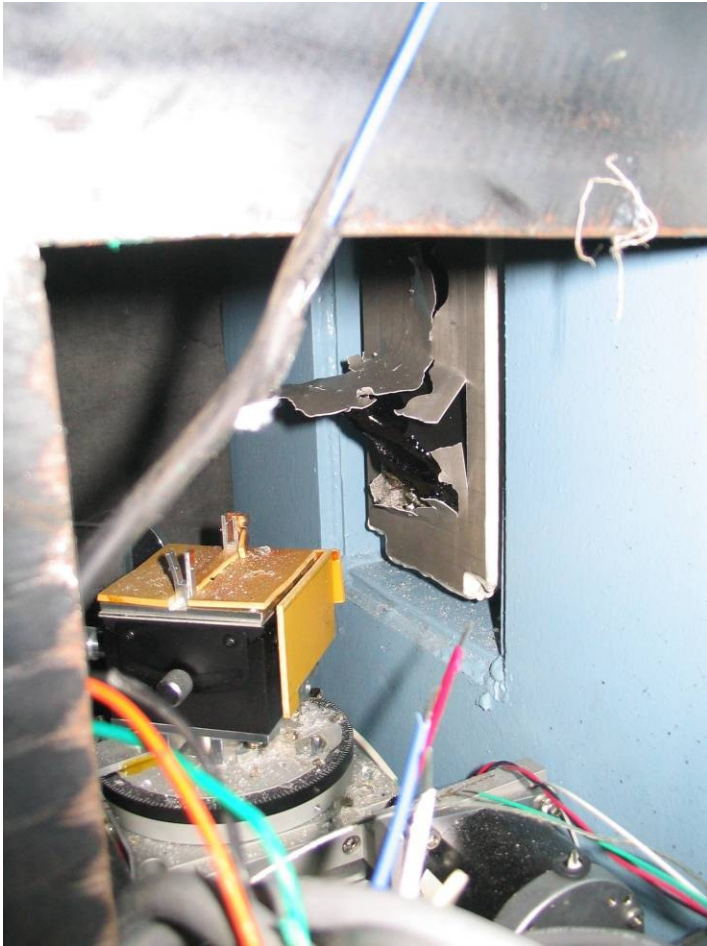
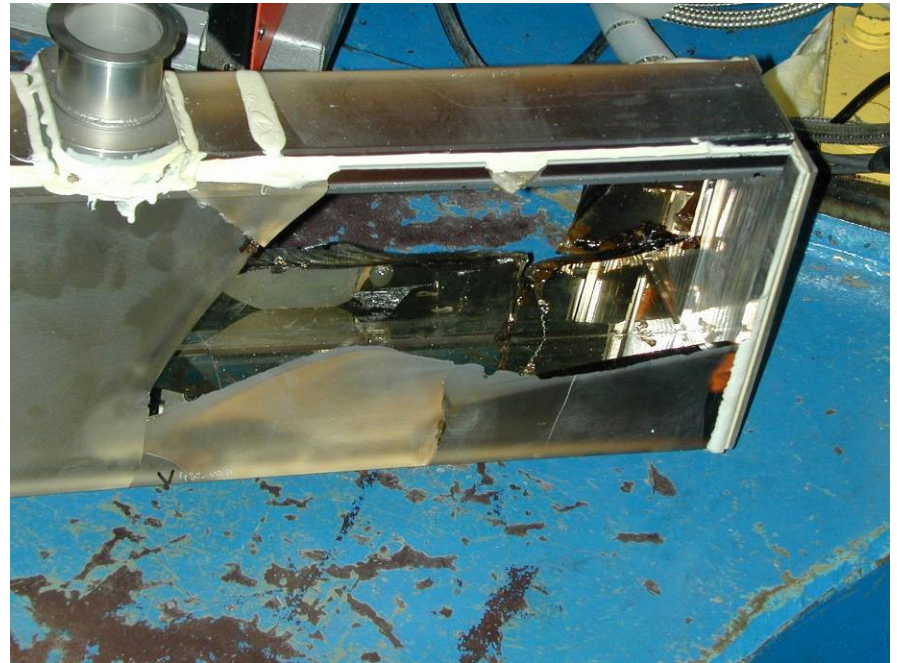
# The Problem

- Neutron guide tubes are made of glass, polished flat and coated with Ni metal (or other materials)
- Most of the glass used is of the borosilicate type, in order to make use of the excellent mechanical properties
- When neutrons are captured in boron,  $\alpha$ -particles are emitted, causing radiation damage
- While  $\gamma$ -radiation does cause damage, it is much less destructive than the  $\alpha$ -particles (leads to color centers – dark brown)

- For regions of the guides away from the source, the guides are maintained under an internal vacuum, putting the walls under stress
- When the glass is sufficiently damaged, the guide can fail suddenly (implosion), causing a sudden loss of vacuum, and concomitant pressure wave and debris acceleration

- The problem is directly attributable to radiation damage caused by neutron capture and  $\alpha$  emission
- Therefore, prevent neutrons from hitting the glass
- Very well fabricated masks after any guide gap that cover the entire guide end, with very close tolerances (EDM of BAI)
