Transient Rod Drop Time

A Synopsis of a Reportable Event

Radiation Science and Engineering Center

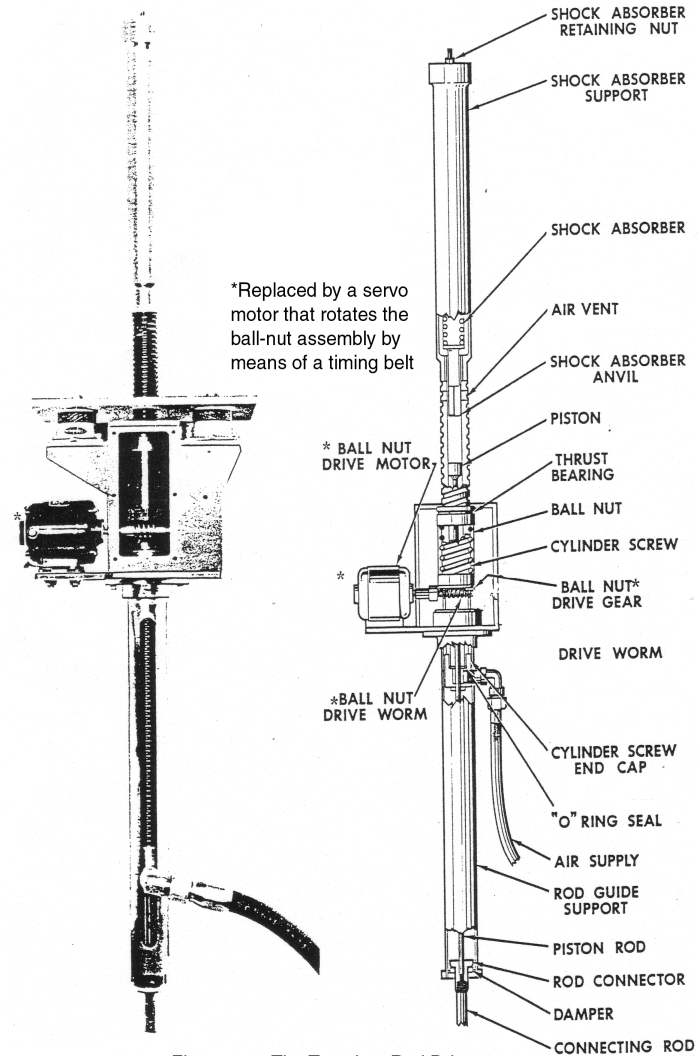
Figure 4.17 The Transient Rod Drive

- Transient rod is a pneumatically coupled control rod. Used primarily for steady-state operations and reactor pulsing.

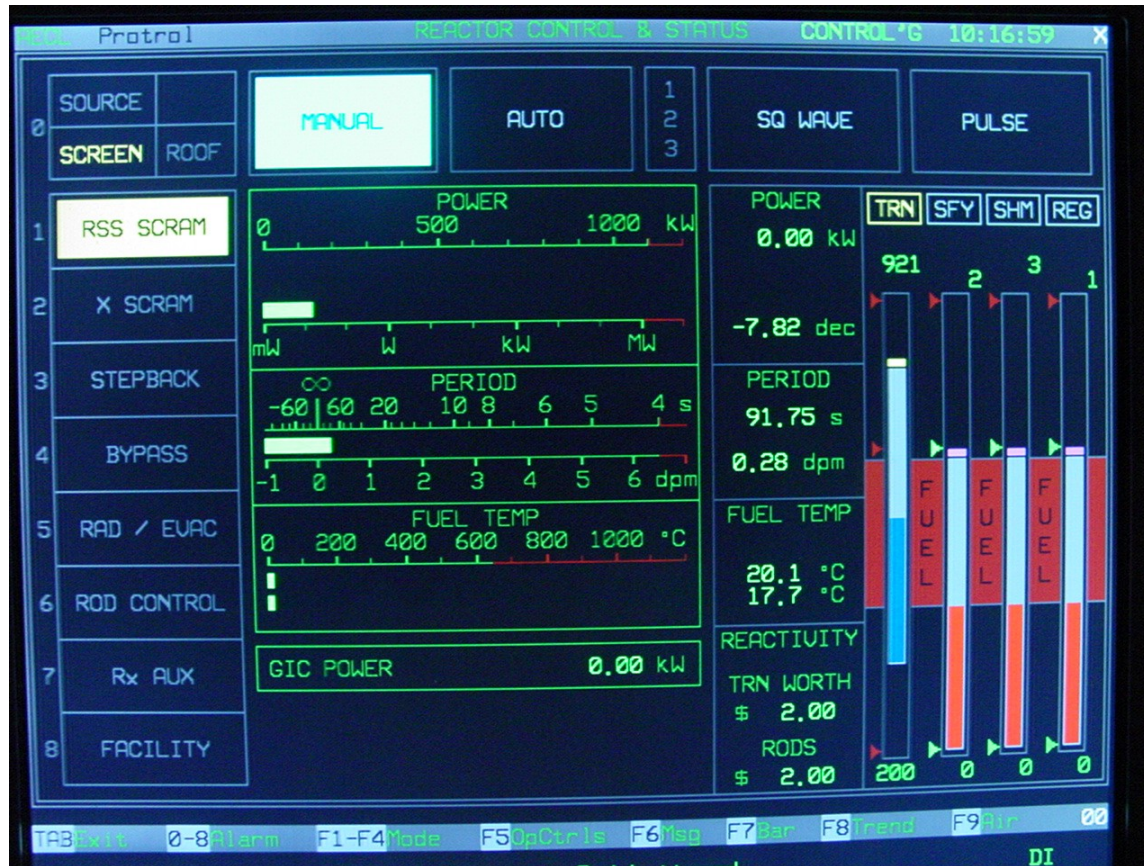
DCC-X Control Computer

- During a Nuclear Engineering laboratory, Reactor Operations and Testing, the Tr rod appeared to be slow falling into the core after a pulse trip as observed on DCC-X by the operator.

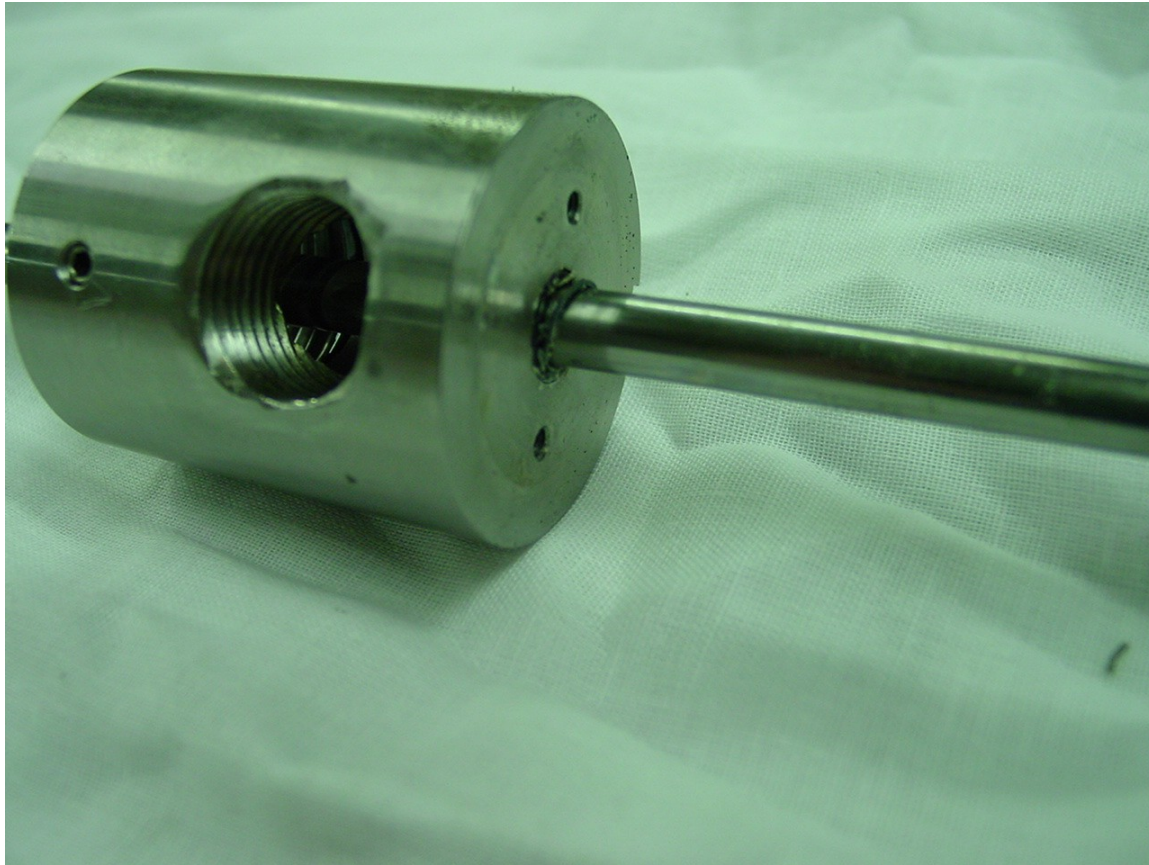
Cylinder End Cap with Damaged Kapseal

- The damaged teflon Kapseal allowed the o-ring to contact the piston rod drastically increasing the friction.
- The seal was damaged by increased pressure exerted against the rod by the swollen o-ring.

- Initially we implemented daily rod drop measurements, which, based on the data has been increased to weekly and now monthly.
- The CCP-9 Transient Rod Inspection has been modified to inspect and /or replace the Kapseal and o-ring annually.
- Lubricant is specifically identified.
